COUNTRY East Germany

SUBJECT Stendal Airfield

EAST GERMANYAIR/MILITARYSTENDAL AIRFIELD - Reconstruction
progress as at 26 July 57.

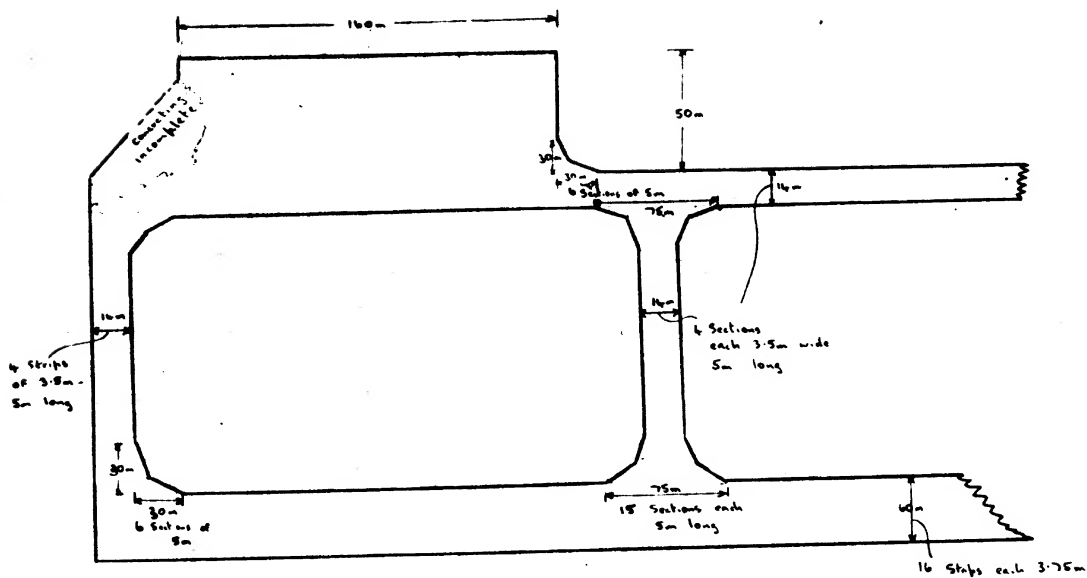
APPENDIX A

Attached at Appendix "A" is a rough sketch plan showing the method of concreting the fillets at the junctions of the runway and transverse taxiways.

To date seven extensive concrete fillets have been laid down at the western end of the runway/taxiway (see sketch at Appendix "A"). The fillets have been constructed in two parts, an initial [] portion, to which a further [] portion has been added, giving the hypotenuse a slight indentation. The two fillets at either end of the inner transverse taxiway, combined with the width of the taxiway itself, have an overall face length of [] 15 sections []. Similar [] fillets have been added to the inside of the outer transverse taxiway, and also to the eastern side of the new hardstanding nearing completion in the NW corner. The corresponding fillet on the western side has not yet been completed.

STENDAL AIRFIELD
method of Concrete
Runway/Taxiway Fills

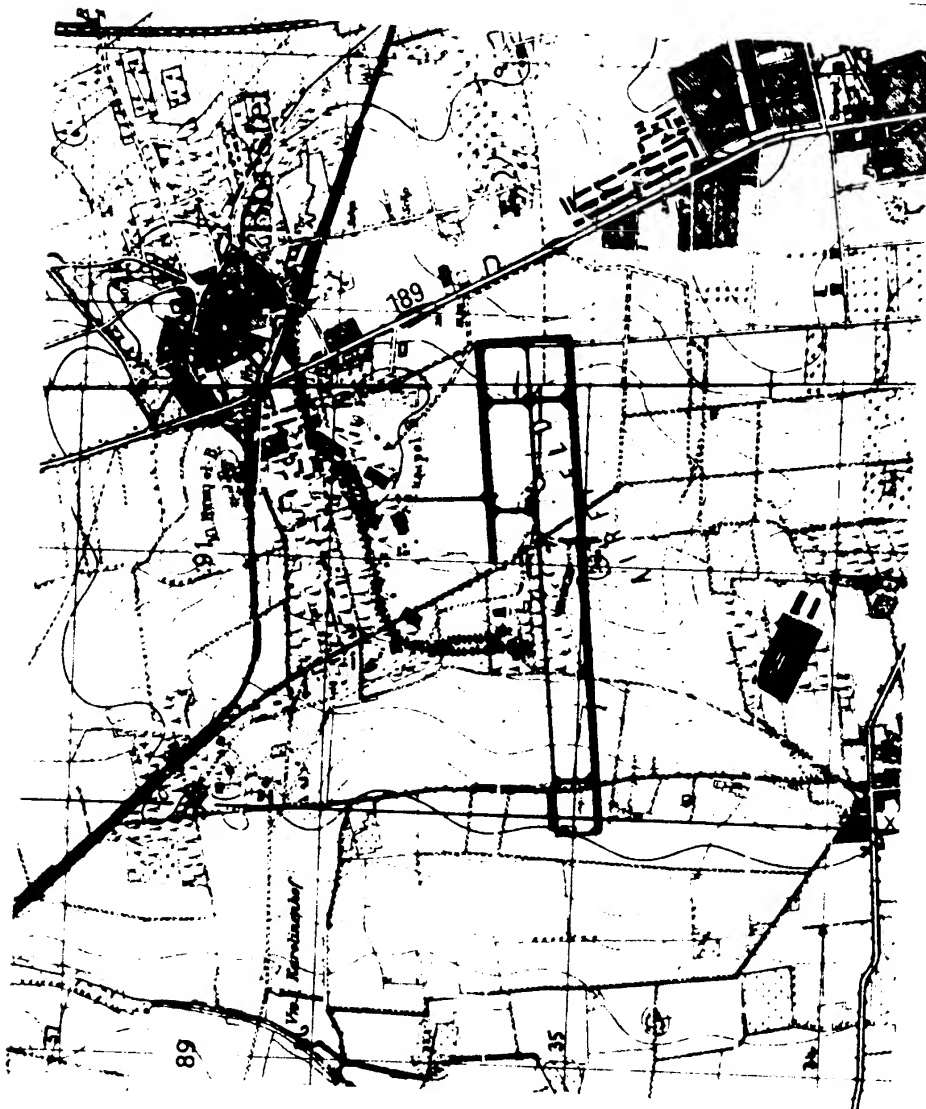
Attached at Appendix "B" is an overlay from local 1/25000 maps showing relative layout of the runway and parallel taxiway with the projected associated hardstandings.
